## Hewlett-Packard Model 405CR Repair Notes

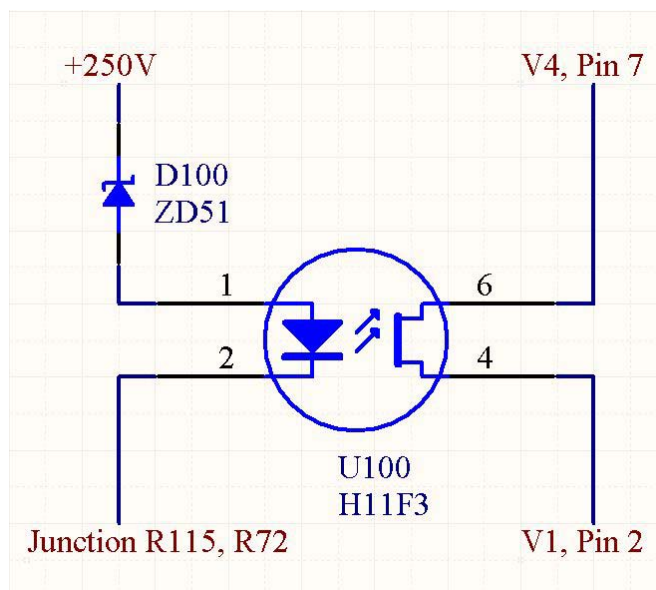
If the voltmeter does not zero and its display is nearly constant regardless of input signal or range the photocoupler formed by neon lamp DS7 and photoresistor V23 may be defective. First check the signals according to the voltmeter's manual page 8, figure 4-2, to be sure that internal timing is correct. While DS7 can be checked easily by observing its flashing light, the photoresistor switches small signals in a high impedance environment. Check V23 off the circuit.

Loose the two wires to V23 and make sure they don't contact to any other part or the chassis. Connect an ohmmeter across the pins of V23. Connect one end of a resistor (47k $\Omega$ , 2W) to the junction of DS7 and R72. Be sure that the other end has no contact with other parts. Power-on the voltmeter and check the dark resistance of V23 which should be higher than 3 M $\Omega$ . Connect the added resistor's open end to ground (chassis) to force DS7 to light. The resistance of V23 should now drop to less than 5 k $\Omega$ .

If these values are not met, the photoresistor is aged or defective. Usually a direct replacement part is not available, so you have to use a solid state alternative. Remove DS7, V23 and the black mounting box from the circuit. Add a photocoupler Fairchild H11F3 plus a zener diode (zener voltage between 47V ... 56V, power dissipation >1,3W) as shown below:

Please note that the H11F3 is the only photocoupler that will do the job. Standard photocouplers with transistor output do have a collector-emitter voltage while the H11F3 output is "pure resistive".
